HICKORY HILLS GOLF CLUB LAKE DAM (NO NAME NO. 235)  
JEFFERSON COUNTY, MISSOURI

MISSOURI INVENTORY NO. 30403

PHASE I INSPECTION REPORT  
NATIONAL DAM SAFETY PROGRAM

SEPTEMBER 1978

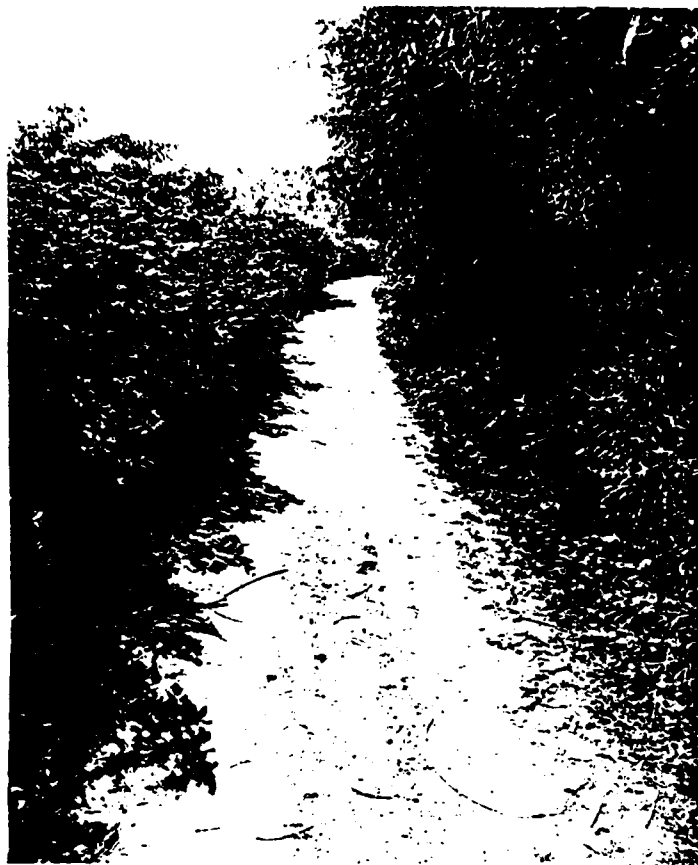
c. Dam. The dam is extremely overgrown with vegetation. Large willows are present along the entire upstream face; the downstream face is covered with trees, thick brush, and vines. The crown is bare earth and is used as a golf cart path.

d. Appurtenant Structures. The spillway consists of a shallow swale in the left abutment with a 12-inch steel pipe underneath. No erosion protection is provided. A pump in the lake near the dam was found to provide water for adjacent golf greens. A small depression in the dam crown revealed a broken 2-inch plastic

pipe just below the surface which is apparently part of the green watering system. No other appurtenant structures are a part of this dam.

PHOTO NO. 7    Hickory Hills Country  
Club Dam - Dam Crown
